# **Specification Synthesis and Recommendations for Repairing Uncontrolled Cracks that Occur During Concrete Pavement Construction**

**April 2000**

**By  
Gerald F. Voigt, P.E.  
Vice President - Technical Operations  
American Concrete Pavement Association  
5420 Old Orchard Road, Suite A100  
Skokie, IL 60077-1059  
Phone: 847-966-2272; Fax: 847-966-9970  
Email: [gvoigt@pavement.com](mailto:gvoigt@pavement.com)**

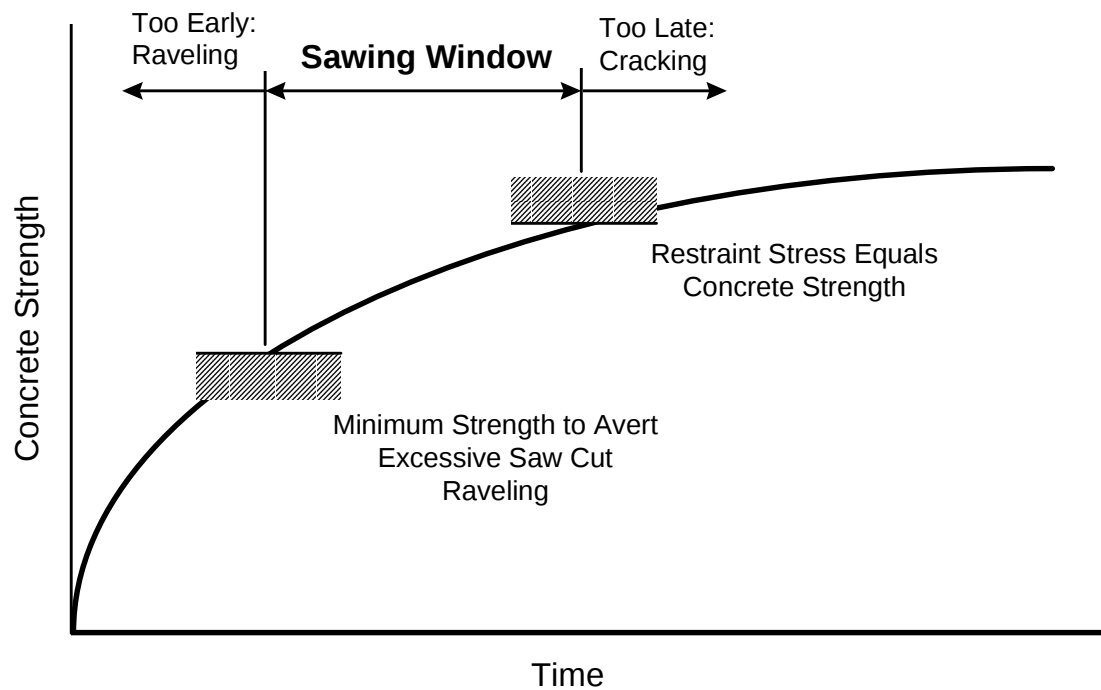
Figure 1. The sawing window.(2)

There is an optimum time to saw contraction joints in new concrete pavements, which is defined as the sawing window (Figure 1) (2,5). The window is a short period after placement when the concrete can be cut successfully before it cracks. The window begins when concrete strength is acceptable for joint sawing without excessive raveling along the cut. The window ends when significant concrete shrinkage occurs and induces uncontrolled cracking.

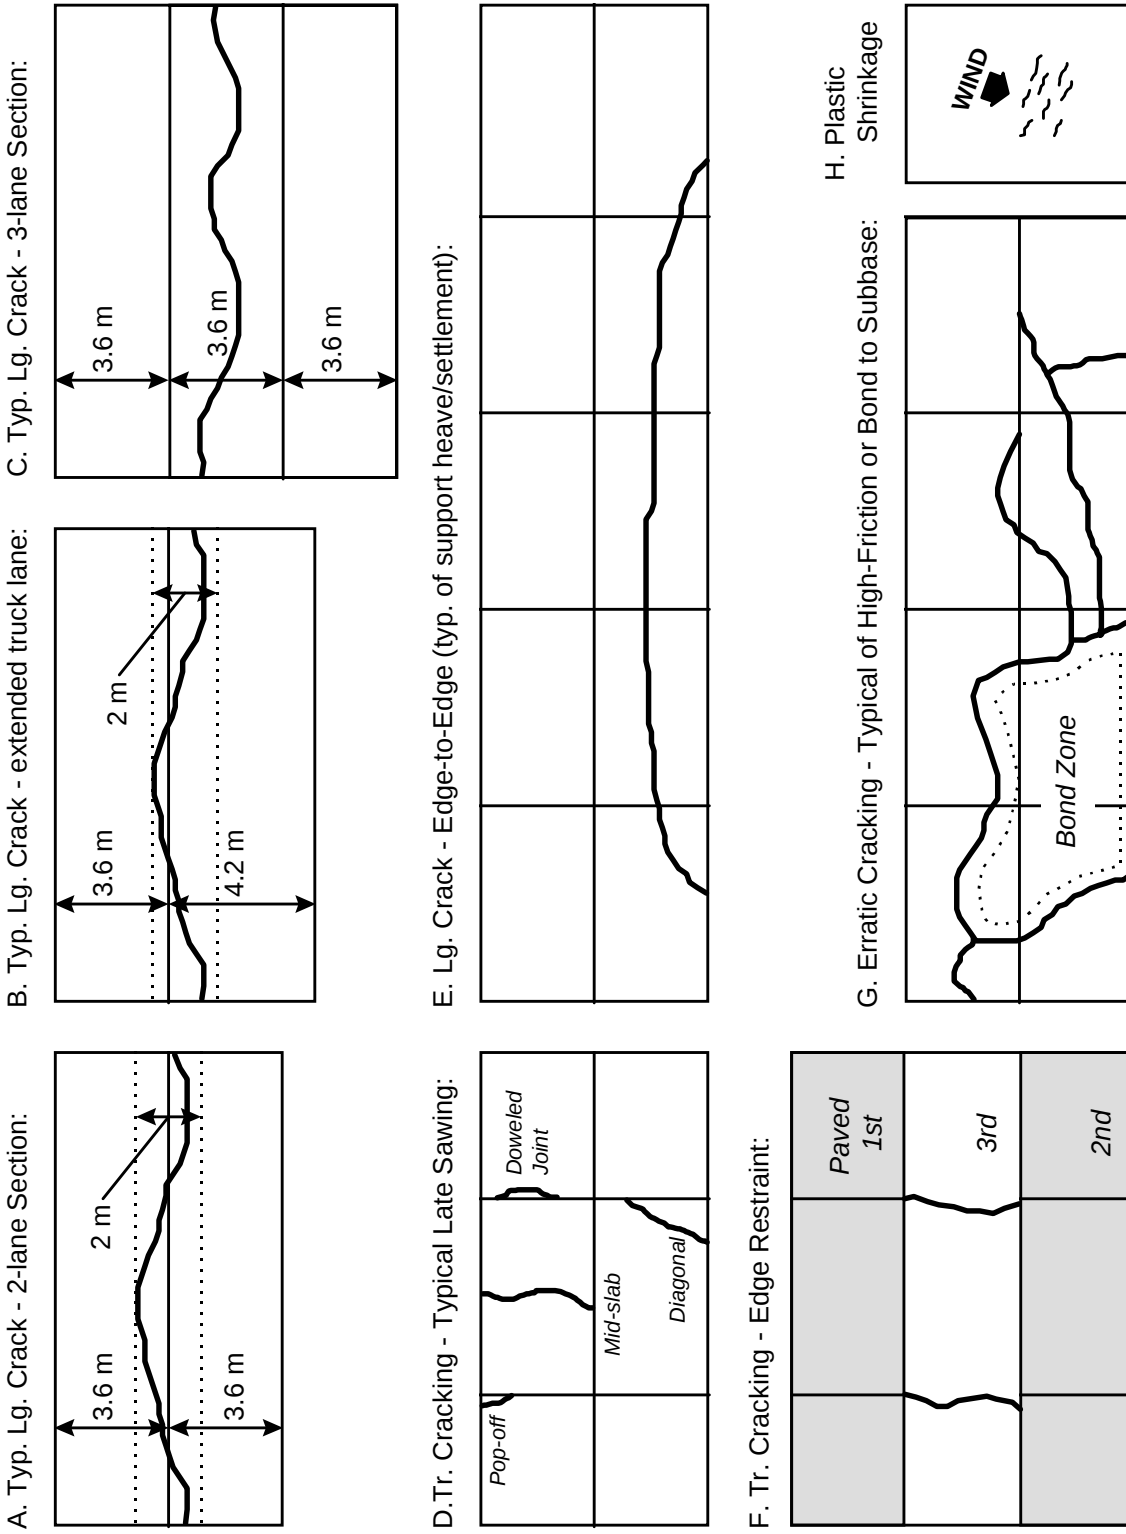
Figure 2. Typical early cracks on newly constructed concrete pavements (1 m = 3.28 ft).

The orientation of uncontrolled cracks can indicate the possibility that sawing was too late. If a crack reverses direction, or develops in an unusual orientation, it may have initiated at the bottom of the slab and may have been influenced by high friction or bonding to the subbase (2). When an uncontrolled crack extends across the entire width of a paving slab, or begins and ends at a functioning joint, the possibility of late sawing remains. In most cases uncontrolled longitudinal cracks from late sawing will be in predictable locations as depicted in Figure 2A-C. Transverse cracks from late sawing are less predictable, but generally extend across the entire slab or traverse diagonally (Figure 2D).

At or near the end of the sawing window, cracks may form while the saw operator is making a cut. These cracks often occur as the saw progresses to within about 1 m (3 ft) of the free edge of the slab (Figure 2D). Pop-off cracks are an indication that sawing is too late for the prevailing conditions. There is a higher tendency for pop-off cracks if a high wind is blowing against the edge of the slab, accelerating evaporation and shrinkage. Experienced saw operators will orient the direction of sawing with the wind whenever possible.

Cracks from bonding to the subbase are likely to initiate from the bottom of the slab and travel toward the slab surface, sometimes reflecting from shrinkage cracks in the stabilized subbase. Cracks from high friction can be erratic in orientation, sometimes reverse direction and seem to follow zones of restraint between the concrete and subbase (Figure 2G).

The influence of dowel alignment on the development of early cracking is not well understood. If saw timing and saw cut depth are adequate, the misalignment of dowels can induce a crack away from a transverse joint if the dowels physically lock two slabs together and restrain their contraction (Figure 4). For this possibility, a crack must exist that extends below the saw cut. If there is no crack meeting the saw cut, then late sawing or subbase restraint is likely the cause of the uncontrolled crack. In some cases a crack may wander in and out of a saw cut above a doweled joint (Figure 2D). This also indicates that sawing was too late for the prevailing conditions.

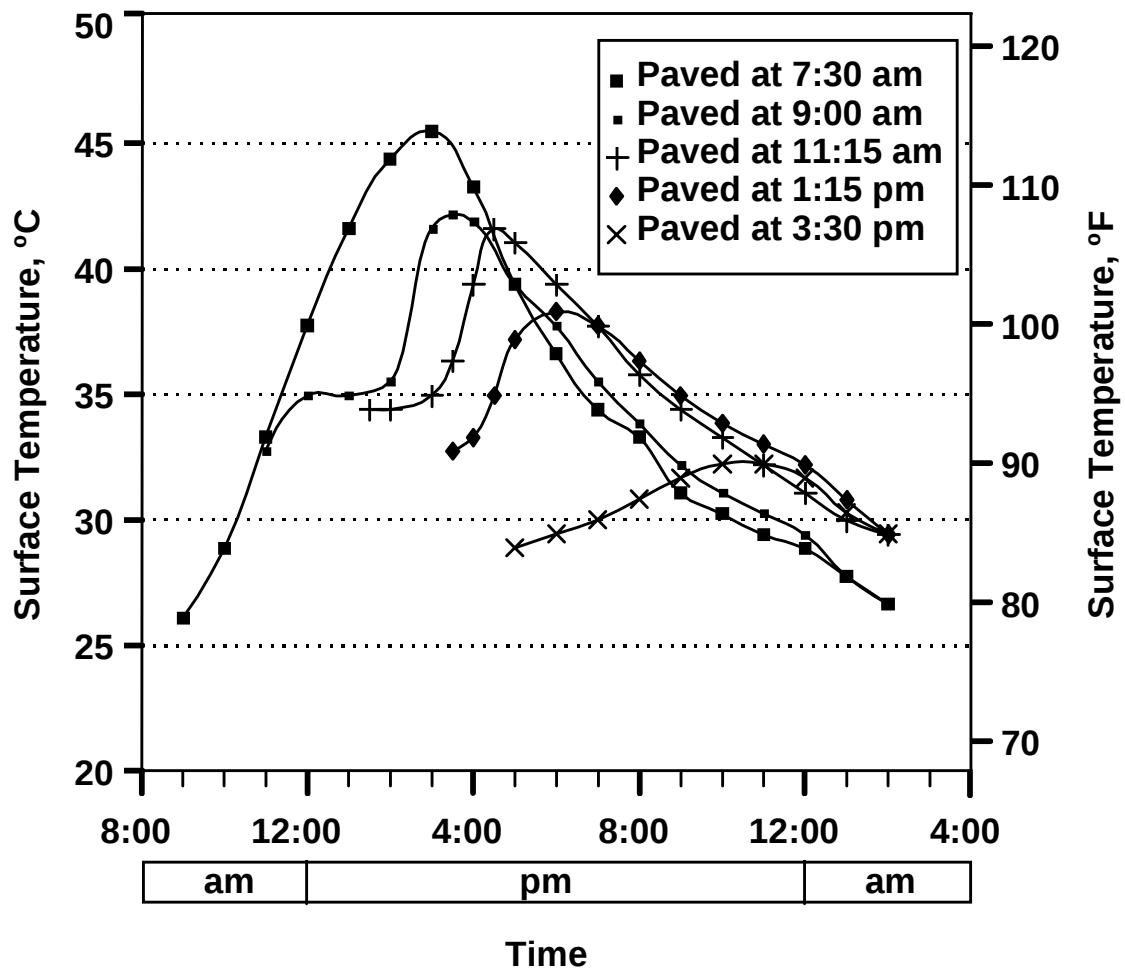
Figure 3. Surface temperatures of pavement slabs paved at different times of the day. (5)

Under warm sunny summer conditions, the maximum concrete temperature will vary depending on the time of day when the concrete is paved. Concrete paved in early morning will often reach higher maximum temperatures than concrete paved during the late morning or afternoon because it receives more radiant heat (Figure 3). As a result, concrete paved during the morning will generally have a shorter sawing window, and often will exhibit more instances of uncontrolled cracking.

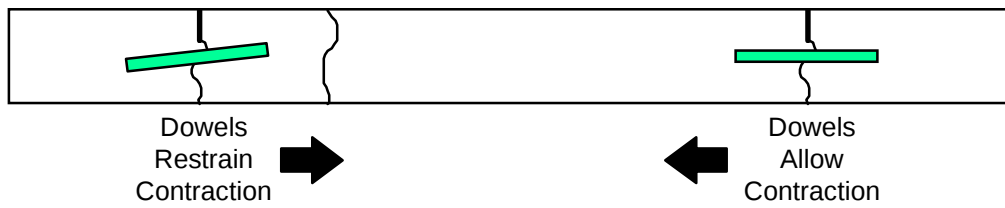
Crack likely a result of late sawing

Crack likely a result of restraint by misaligned dowels

Figure 4. Mechanism necessary for cracking caused by misaligned dowel bars.

An unanswered question is whether misalignment of dowels can ever induce a crack to form away from a saw cut if there is no crack extending from the cut. This would require that the dowels reinforce the concrete and mask the presence of the weakened plane. Since tied longitudinal contraction joints create significant restraint, without alarm for unusual cracking, it seems reasonable the same would hold true for misaligned dowels.
